WITHOUT IT YOU HAVE NO DAY...

Editor's Note: This article is based on a research paper prepared by Class Number 4, Communications Group, at the Sergeants Major Academy (Fort Bliss, Texas). For whatever political failure it may have been, Vietnam was not a military failure. It produced new examples of the valor of the American Soldier and demonstrated new plateaus of mission accomplishment. But, it is from this story, as our last and most recent combat experience, that we must learn. It is imperative that we not only correct the short-comings noted in our Vietnam operations but also our successes must be the basis for developing and projecting future signal operations in a combat environment.

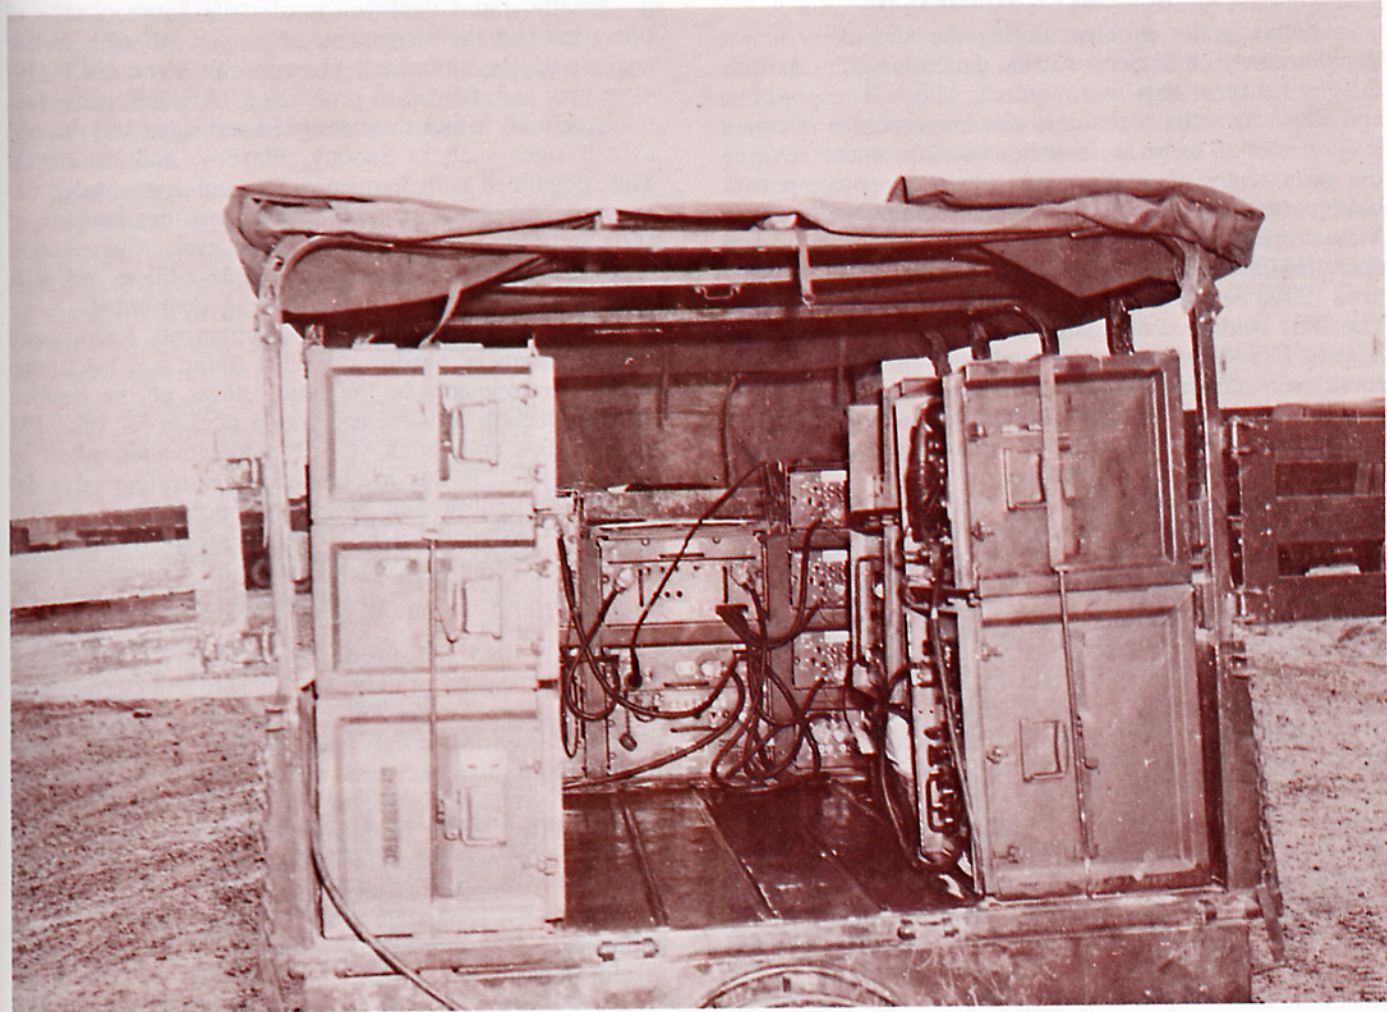
Trailer-mounted configuration of the AN/MRC-34½.

During this period, the 1st Air Cavalry Division (earlier known as the 11th Air Assault Division) designed totally new assemblages using existing components. The results were: the AN/MRC-111, AN/MRC-112, and the AN/MRC-34½. At the same time, signal units providing sup-

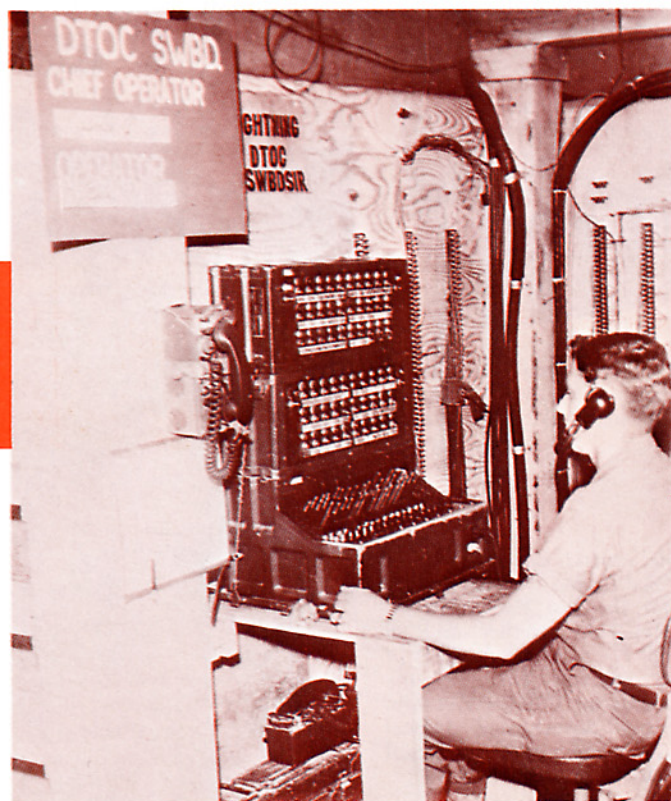
The SB-86 switchboard often proved fragile due to their vulnerability to moisture.

port at the tactical level were experiencing various problems such as the unreliability of small generators in a 7-day-a-week situation. Additionally, tactical switchboards (SB-22 and SB-86) often proved fragile due to their vulnerability to moisture.
